Carbon fibre sheet moulding compounds with high in-mould flow: linking morphology to tensile and compressive properties

In-mould flow during manufacturing of Sheet Moulding Compounds (SMCs) heavily affects the material microstructure and its mechanical properties. This influence is studied here for carbon SMCs on panels compression moulded with limited charge coverage. The high in-mould flow caused severe in-plane tow distortions, while their planarity was preserved. Flow induced fibre orientation plays a paramount role in the material failure, whereas local manufacturing defects had no discernible influence. The properties difference between specimens with preferential orientation of 0° and 90° was 150% for tensile stiffness, 260% for tensile strength, 120% for compressive stiffness and 32% for compressive strength. The compressive strength and failure strain for 45° and 90° specimens were higher than those for tension, and comparable for 0° specimens. Compressive and tensile moduli were similar for specimens with the same orientation. A clear link between SMCs manufacturing and mechanical performance is highlighted, together with its implications on structural design.

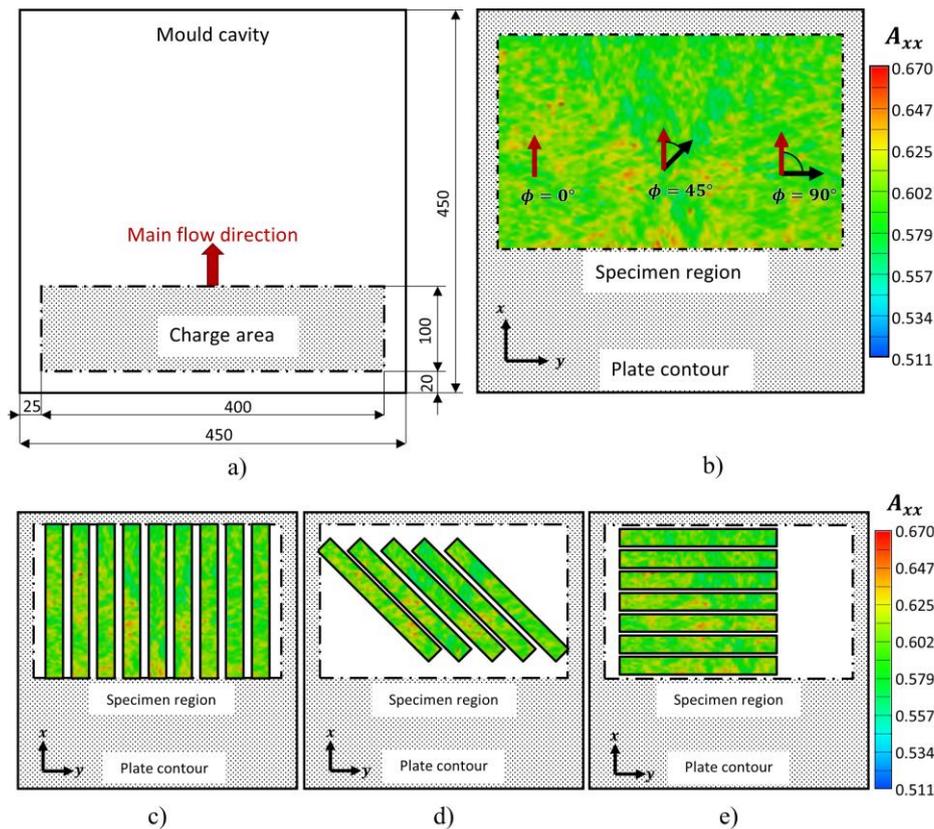
Fig. 1 Compression moulding of plates and specimens manufacturing: a) charge placement before the mould is closed, b) moulded plate, and cutting location of the c) 0° , d) 45° and e) 90° specimens. Predictions of the x component of the orientation tensor inside the specimens' region are shown.

To assess the variation of fibre orientation inside the specimen cutting region, Moldex3D simulations were performed. Fig. 1.b shows the field of x component of the orientation tensor [32]. The Moldex3D fibre orientation model [33] was calibrated to obtain an average orientation tensor in the specimen region as close as possible to the one measured and reported in section 3.1. The calibrated parameters are: the fibre-fibre interaction parameter C_I equals to 0.03, the fibre-matrix interaction parameter equals to 0.9 and the α parameter is 0.7. The software predicts a less oriented state as flow progresses from the charge area to the opposite border. This has less important implications on the 0° and 45° specimens, as their length spans the entire x direction of the region (see Fig. 1.c and Fig. 1.d). This is not true for the 90° specimens (see Fig.

Several plates were compression moulded with dimensions 450 mm x 450 mm, and a thickness of 2.5 mm. The procedure is illustrated in Fig. 1.a and Fig.1.b. The moulding temperature, pressure and time was 141.5 °C, 215 bar and 180 s respectively. The initial charge, made of six sheets of prepreg material, occupied about 20% of the

available cavity. This was done to promote significant flow in the compression moulding phase, and hence reorient the fibres along the flow direction. Specimens were then waterjet-cut from the upper region of the plates at angles of 0° , 45° and 90° (Fig. 1.c, Fig. 1.d and Fig. 1.e), with respect to the main flow direction. For the rest of this paper, they will be referred to as “ 0° ”, “ 45° ” and “ 90° ” samples respectively. The specimens were cut at least 25 mm far from the plate borders, to avoid any mould edge effect.

The morphology of the material is described using the global coordinate system, as shown in Fig. 1: x direction is the dominant flow direction, y is orthogonal to x in the plane of the plate, z is normal to the plate. The z coordinate is indicated as starting from the bottom surface.

Compared to the measured orientation tensors, the average one predicted by Moldex3D was accurate (see Fig. 1). This, however, came as no surprise, since those components were used for the calibration of the orientation model itself. The difference of the

extreme values of the orientation tensor components, instead, arises from the different sizes of the averaging volumes. Remembering that orientation tensors are properties averaged per volume, in Fig. 1, the values are averaged per mesh element (few mm^3). In Table 2, they are averaged over a volume of approximately 25 mm x 30 mm x 2.5 mm.

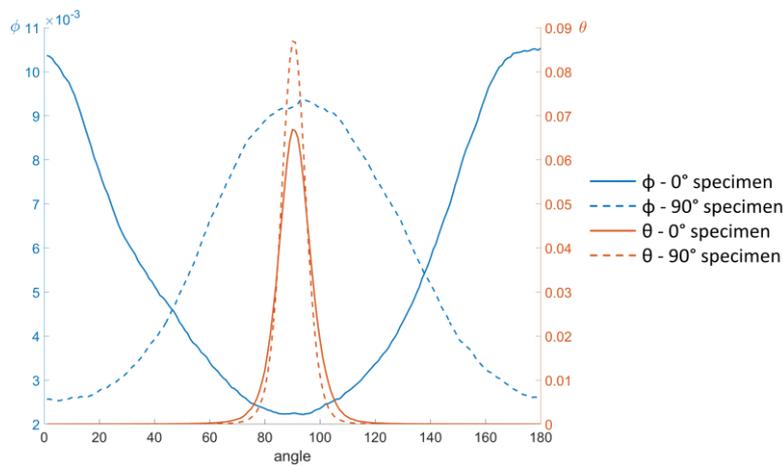
Fig. 2. Fibre orientation distribution functions for the 0° and for the 90° specimens.

The orientation distribution functions for the 0° and 90° specimens are shown in Fig. 2. For both of them, the out-of-plane angle θ shows a variance similar to that observed in [17,18] for UT-CTT. For thin panels it is thus reasonable to assume that the planar nature of TBDC is preserved irrespective of the amount of flow inside the mould. This is true even when dealing with highly distorted tows (see section 3.2). By comparison, the dispersion of the in-plane orientation ϕ was much larger, even if a clear main orientation is present. Finally, the difference in the peak values of ϕ and θ between the two specimens is believed to be caused by the variability of the orientation process.

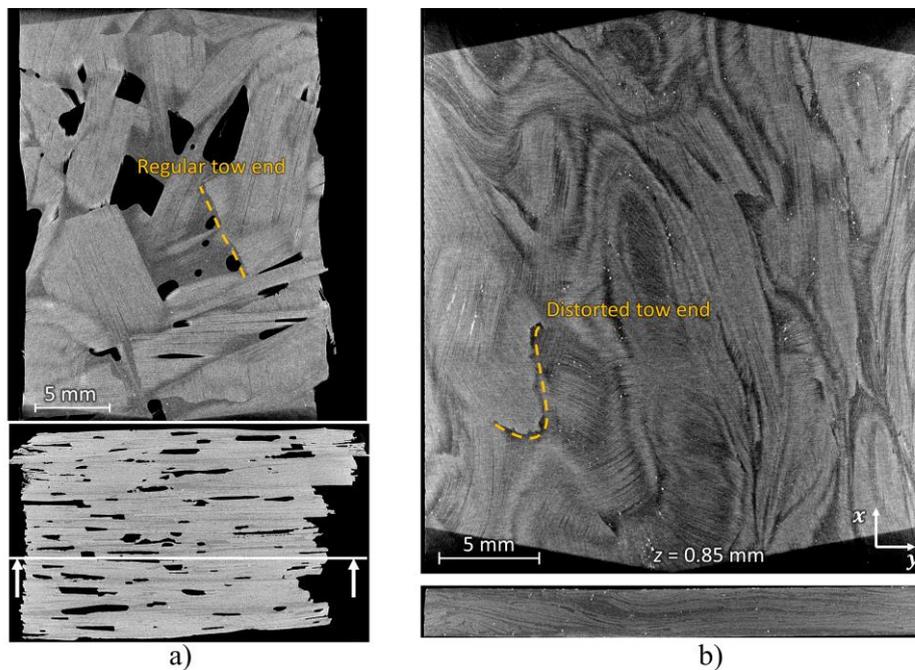
Fig. 3 shows μCT slices of the unprocessed SMC stack and a 0° and a 90° specimens. In the prepreg stack, the tows have a net rectangular shape, with fibres mostly straight. In contrast, the flow of material during the compression moulding has distorted the tows in the manufactured specimens both in-plane and out-of-plane. Although two adjacent tows can still be distinguished, the tows have lost their initial shape almost everywhere.

Fig. 3. μCT scans of a) unprocessed prepreg stack and b) a 0° specimen, for which the flow direction is along x-axis.

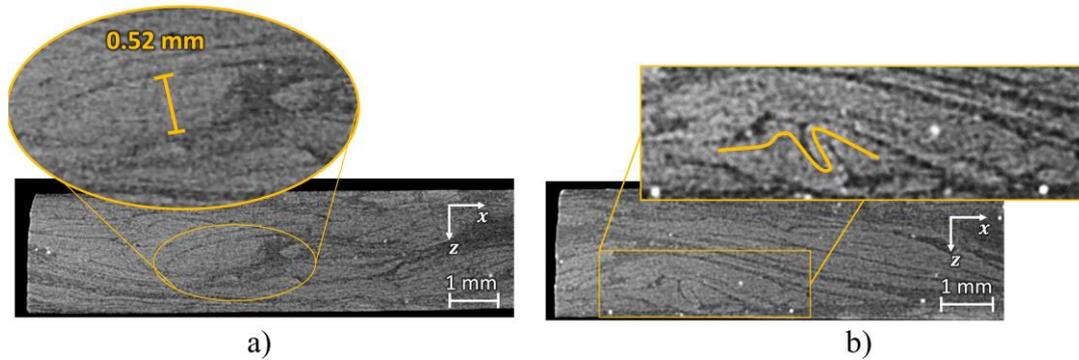
Out-of-plane deformation causes tow waviness, which is almost absent in the unprocessed stack. Swirls are also created: Fig. 4.a shows a tow whose thickness has increased up to 0.52 mm. As a comparison, the standard thickness for the tows range from 0.08 to 0.15 mm, as indicated by the manufacturer. Fig. 4.b shows a wrinkled tow, which is a sign of intense deformation. Despite the high distortion, the tows are rarely split into individual fibres, and their meso-structural entity still exists.

Fig. 4. Flow induced defects observed in the cross section of a 90° specimen: a) tow thickened by a swirl and b) wrinkled tow.

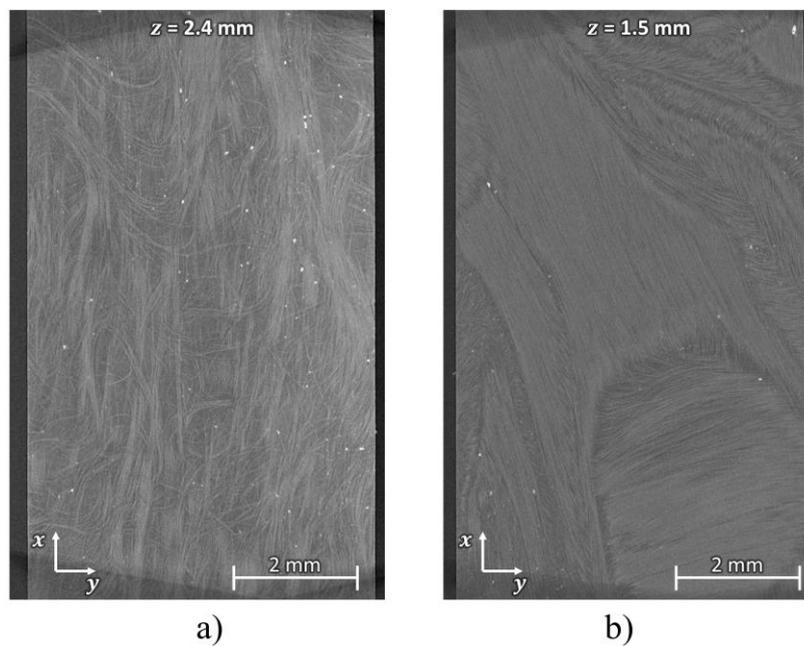
Within 200 μm from the top and bottom surfaces of the panel, however, tow distortion can be much more intense. The tows tend to disintegrate into individual fibres. This feature is evident in the 4 μm resolution scan. Skin and core observed in these scans are shown in Fig. 5. Compared to the observations of Le et al. [24], tows in the skin layer of carbon SMC are less distorted than the ones in the skin of glass SMC. Higher tow integrity in the core is caused by less shear stress arising in the core rather than in the outer skins; moreover, it can suggest a plug-like flow into the mould cavity of the uncured SMC. Indeed, the prepreg stack do not show such a feature, confirming it is created upon manufacturing.

Fig. 5. In-plane slices at 4 μm resolution, skin and core evidence: a) 0.1 mm and b) 1 mm from the specimen's top surface. Flow direction is along x-axis.

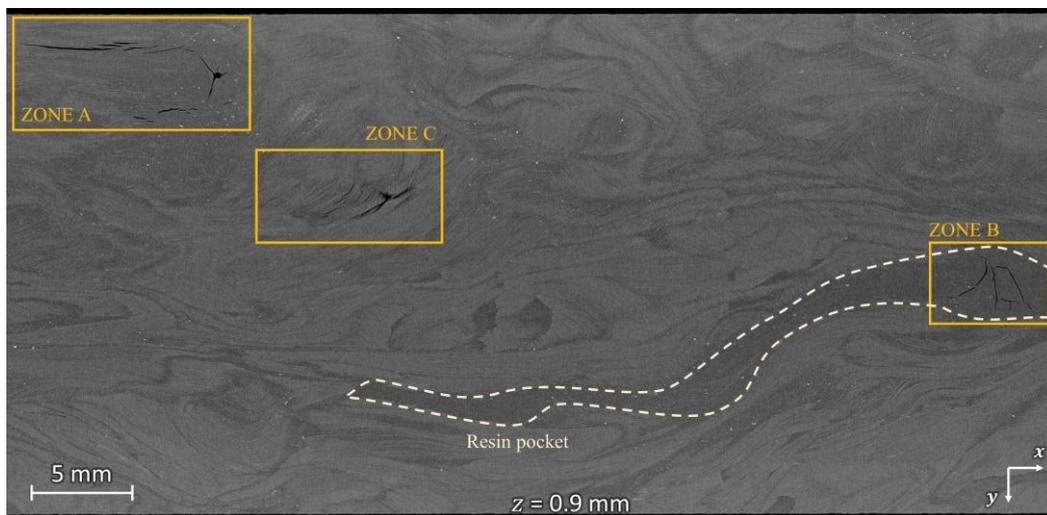
Other defects that appear to have formed during compression moulding are resin pockets, voids and cracks. In Fig. 6, three main defect areas were observed in a single specimen; the defects areas are described in detail in Fig. 7. Slices of zone A are shown in Fig. 7.a; different slicing planes are used to give a 3D description of the defect. The centre of the crack appears to be a spherical defect, from which many delamination-like cracks originate. The spherical shape suggests the defect might be a void caused by air trapped by the high amount of flow [38,39]. Indeed, many voids are present before the compression moulding in the unprocessed stack (see Fig. 3). The combination of smooth and sharp crack profiles suggests that the crack alternatively takes the form of tow/matrix debonding and matrix cracking. This is also observable in Fig. 7.b, where four in-plane slices are shown, each 187.5 μm deeper than the previous. Looking at Fig. 7.a and Fig. 7.b, the voids and cracks seems to affect a low fibre content area (darker regions, where no tows are clearly visible). Starting from the centre of the Fig. 6, another resin pocket (highlighted with a dashed line) extends up until zone B; here (see Fig. 7.c) other cracks are observed where the resin rich area becomes larger. The sharp profile of the crack confirms that those cracks affects mainly the matrix. However, as shown in section BB of Fig. 7.c, they end in a smoother way, suggesting that they propagate as tow/matrix debonding. Finally, smaller cracks are observed in zone C, in Fig. 7.d. Interestingly, these cracks appear to be inside the tow, and they follow the fibre profile and orientation.

Fig. 6. Defects identified in one of the scanned 0° specimens before testing.

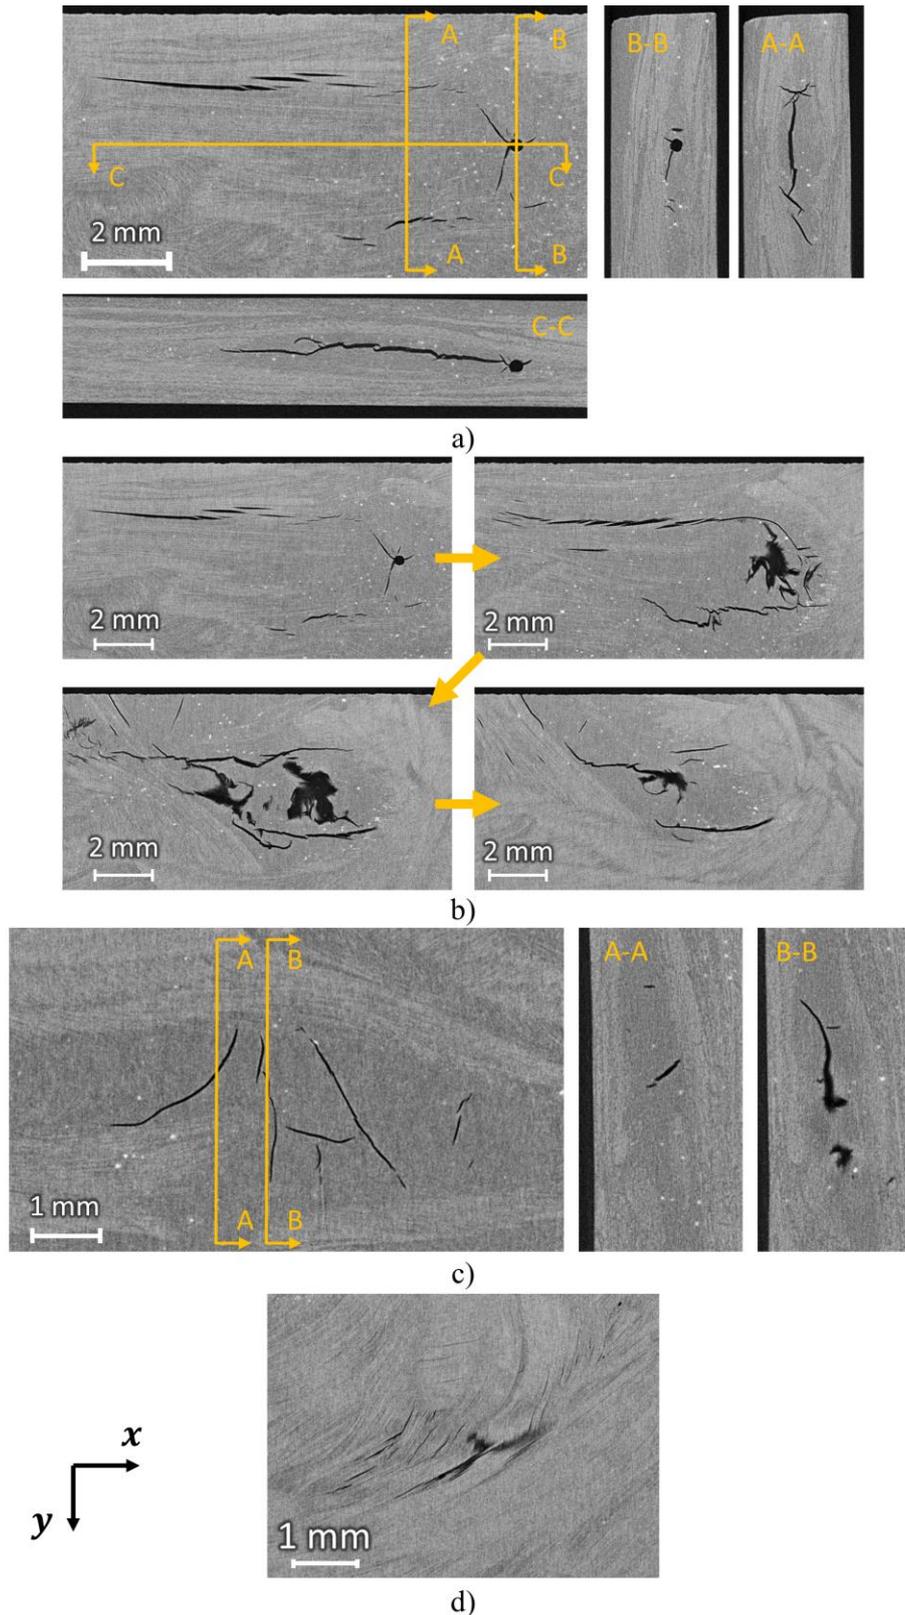
Fig. 7. Gallery of defects observed before testing in Fig. 6: a) 3D observation of void and cracks of zone A. b) The same crack is inspected through the thickness: following the arrows, each slice is 187 μm deeper than the previous. c) Matrix cracks in resin pocket in zone B. d) Intra-tow cracks following the fibre local orientation in zone C.

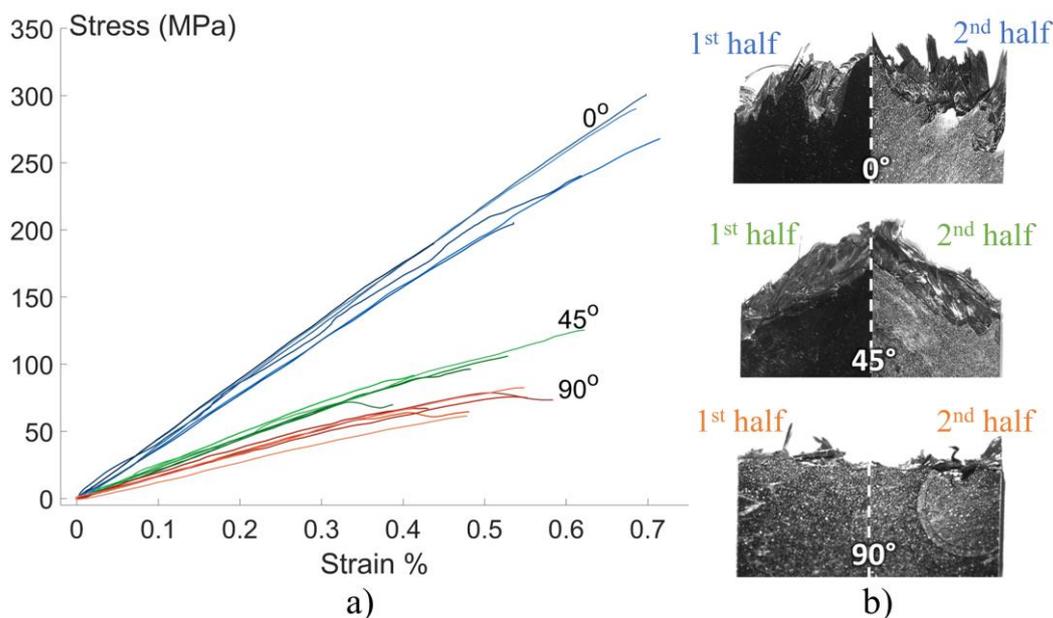
Fig. 8.a shows the stress-strain curves obtained for the tensile tests. Three groups of curves are clearly identifiable, proving the success of the re-orientation of the fibres during manufacturing. Table 3 lists the values of stiffness, Ultimate Tensile Strength (UTS) and failure strain for the different specimens groups. The 2D randomly oriented case is also shown for comparison, as taken from the supplier datasheet [30] and confirmed in literature [11].

Fig. 8. Tensile tests results: a) stress strain curves of the tensile tests on oriented CF-SMC and b) fracture profiles of the two specimens' halves.

In all cases, the specimens remained in one piece even after failure, because of tow intermingling. For one specimen per group, the two halves were separated by manually increasing the cross-head displacement before removing them from the machine, to be analysed with the SEM. Photos in Fig. 8.b were taken with a regular camera after this separation, by putting both halves of the specimens side-by-side. An irregular fracture surface was observed in the 0° specimens, caused by pulled-out and broken tows in the fracture region. The 45° and 90° specimens showed a more regular surface, inclined respectively at 45° and 90° with the main load direction.

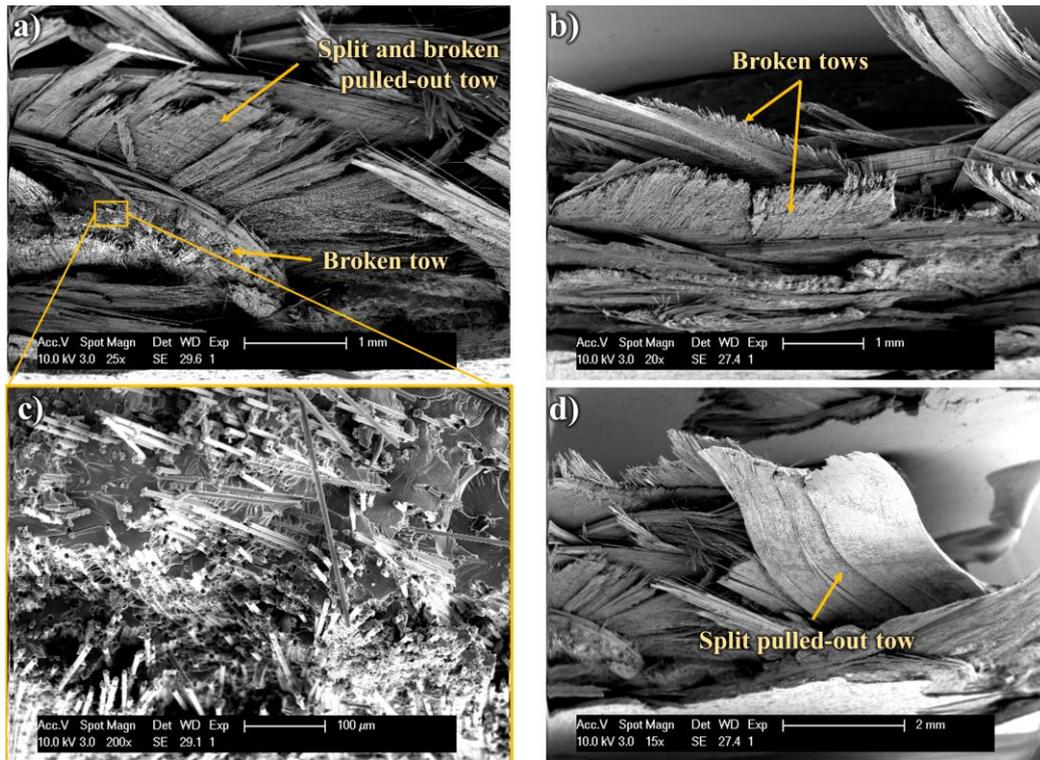
A large number of pulled-out and broken tows was observed in the 0° specimens; less than five tows per specimen were found to be pulled-out and broken from the 90° group. Interestingly, almost all of the tows that were pulled out were also split. Examples of split pulled out tows are reported in Fig. 9.a, 9.b, 9.d, 10.b. and 10.d. It is worth mentioning the matrix damage inside a broken tow in the form of scarps and river markings [40] in Fig. 9.c.

Fig. 9. SEM observation on 0° sample. The images show fibre dominated failures: a-b-d) broken and split tows, split pulled-out ones and the two together. In c) pulled out fibres are visible, as well as matrix damage.

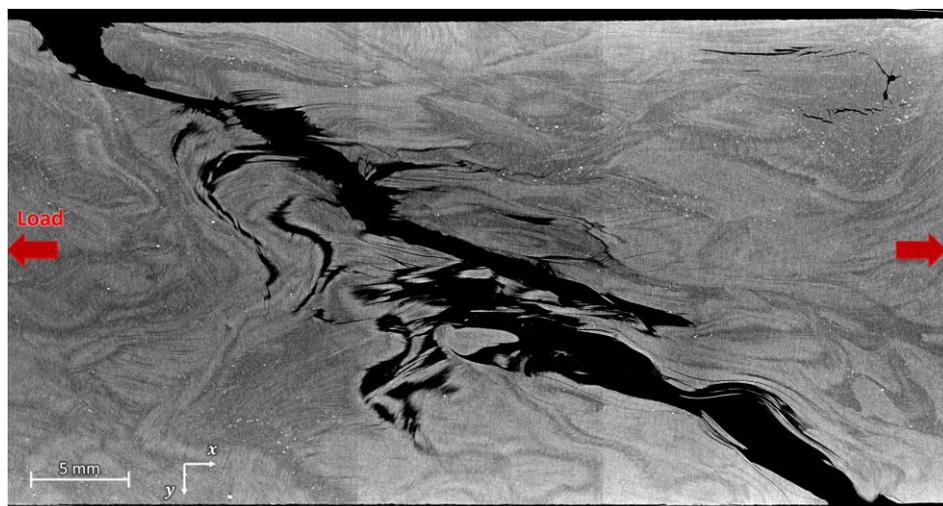
Fig. 10 shows the specimen described in section 3.2, which failed far from all three observed defects; the failure location of that sample was defect free. This observation suggests that strand-based composites are not only insensitive to macroscale notches [19–21], but also to microscale ones and even to small cracks. For this 0° specimen, again tow breakage and pull-out were observed. The crack spread through the tow/matrix interface (debonding) and along the tow ends (matrix cracking).

Fig. 10 Failure of 0° specimen far from defect areas. Red arrows indicate load direction.

Moreover, as observed in Fig. 10, CF-SMC was observed to fail far from manufacturing induced defects and cracks. This suggests that the strain concentrations created by misaligned tows are more important than the stress concentration arising from manufacturing defects. Note, however, that other regions with equal or lower A_{xx} also exist in the sample (see Table 2). This suggests that other factors, like presence and orientation of tow ends, also affect the strength of the SMC. A reasonable hypothesis is that such features determine, among the locations with least favourable orientation, the one that will fail.

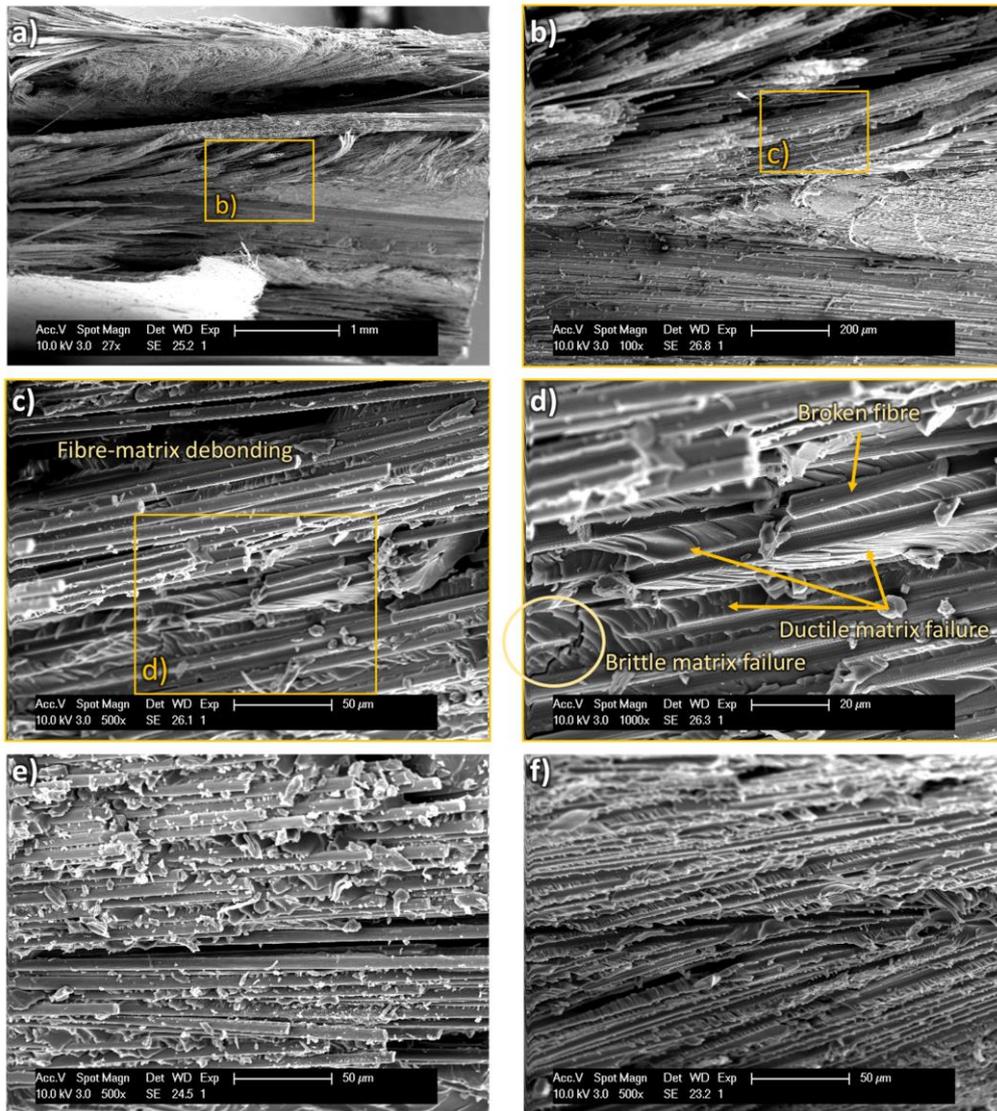
SEM observation on the 90° and 45° specimens showed the matrix dominated failure reported in literature [2,8]. Fig. 11.a to Fig. 11.d report examples of fibre-matrix debonds, both ductile failure and brittle matrix cracking, and even a broken fibre of a 90° tow. Other tows (see Fig. 11.e and Fig. 11.f) were observed to be less clean, proving that debonding was not so intense.

Fig. 11. SEM observation on the 90° specimens with progressively zoomed-in regions from a) to d), and e-f) less clean fibres.

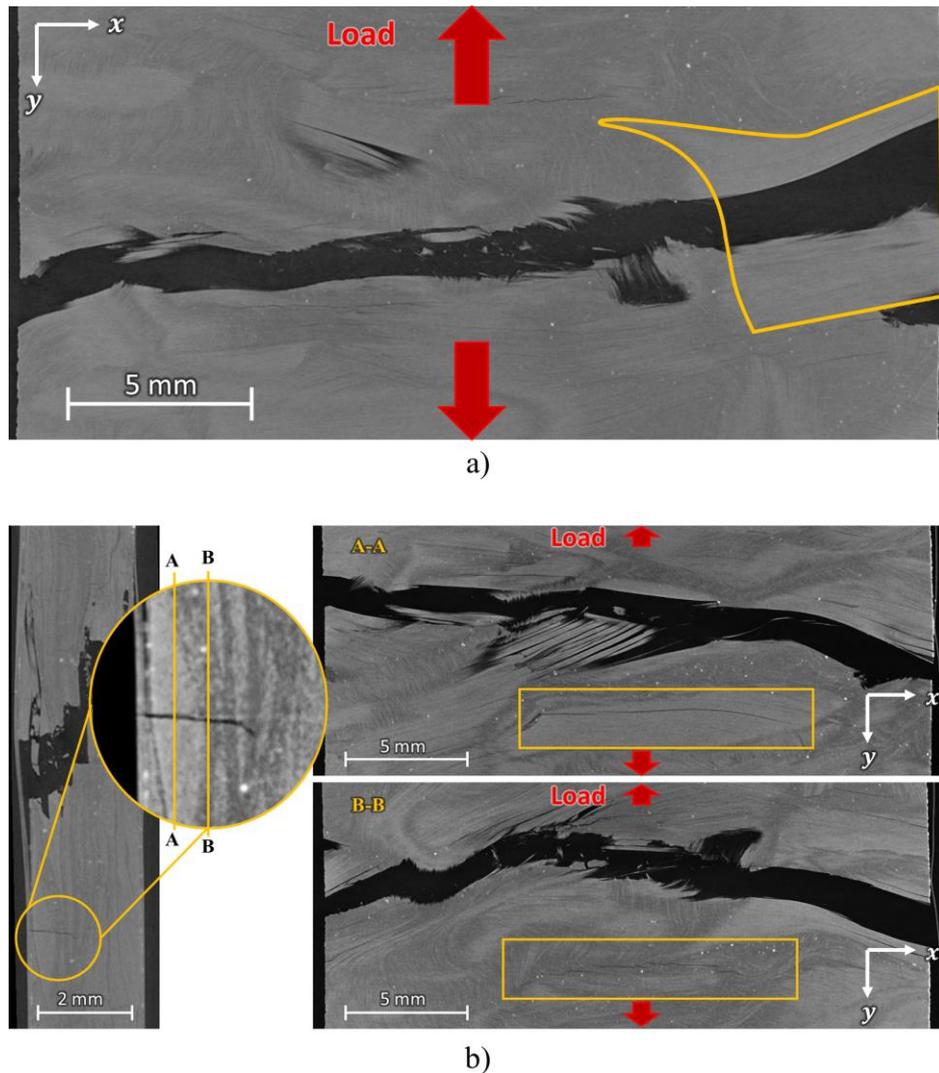
An interesting observation was the presence of intra-tow cracks in the 90° specimens. Fig. 12.a shows the failure location, with a crack running through a tow oriented perpendicularly to the load direction. This feature was also observed away from the failure zone, as reported in Fig. 12.b. This feature was not observed in the 0° scanned samples; however, this might be only due to the lower probability of finding tows perpendicularly oriented to the load direction, rather than to a different redistribution of load due to different fibre orientation.

Fig. 12. Transverse cracks in a failed tensile 90° specimens. a) The failure crack have separated a tow (on the right, highlighted in yellow). b) In slice A-A, the crack is splitting a tow, and has a smooth profile. In slice B-B, crack is irregular, as it is in the matrix. Red arrows indicate load direction.

Fig. 12 can also be used to characterise two different failure modes. When observed inside a tow, the crack appears smooth and linear; this crack is probably an interfacial crack between fibres and matrix. When the same crack is observed in the inter-tow matrix layer, the profile of the crack appear to be irregular, with S-shaped profiles typical of shear failure [40].

It is worth mentioning that cracks running through tow and matrix, as the ones in Fig. 12, were commonly observed in both 0° and 90° compressive failures. Moreover, this also involved tows oriented parallel to the load direction, as shown in Fig. 16.

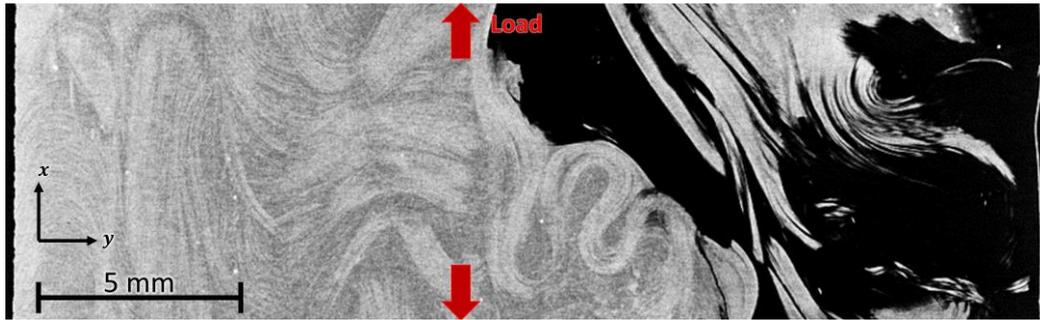
In case of very distorted tows, as the one shown in Fig. 13, the failure profile runs along the external interface of the tow. This suggests that, when high in-plane waviness is present, the waved tow acts as an equivalent weaker reinforcement: its equivalent aspect ratio is reduced, as well as its volume fraction and local stiffness.

Fig. 13. Crack in a 0° specimen following the outer contour of a highly distorted tow. Red arrows indicate load direction.

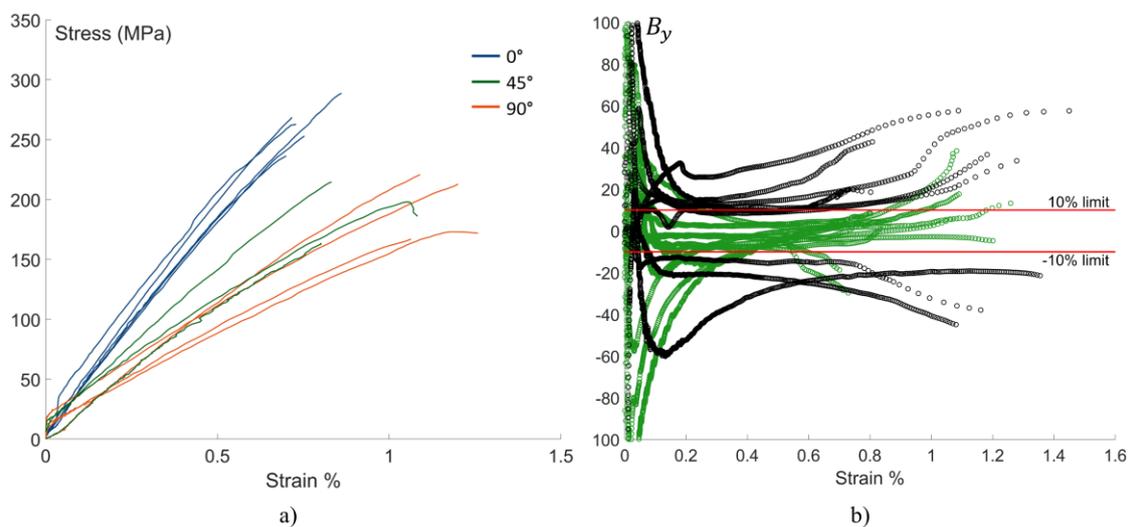
Before analysing the stress-strain diagrams of all the specimens tested in compression, a bending check is performed [35]. Results are shown in Fig. 14.b, where green curves are accepted, and black are rejected. After the check, five specimens out of six were considered to be acceptable for the 0° case, four out of six for the 90° cases, while only three out of nine for the 45° ones. This is due to the intrinsic imbalance of the specimens oriented at 45° . For the 0° and 90° specimens, the number of tows oriented at an angle φ , is statistically the same of the number of tows oriented at $-\varphi$; this is visually represented by the fibre orientation distribution function in Fig. 2. The 45° specimens are instead characterised by an asymmetric fibre orientation distribution function that peaks at either $+45^\circ$ or -45° .

Fig. 14. Results of the compression tests. a) Stress-strain curves and b) bending check for the compression tests: green curves are accepted, black ones are rejected.

Some of the specimens were accepted even if they were subjected to more than 10% bending in the very last phases of the test (see green curves in Fig. 14). This is due to the fact that the crossing of the 10% limit happened after the maximum load was reached.

The stress-strain curves of the valid tests are shown in Fig. 14.a, while stiffness and strength values are reported in Table 4.

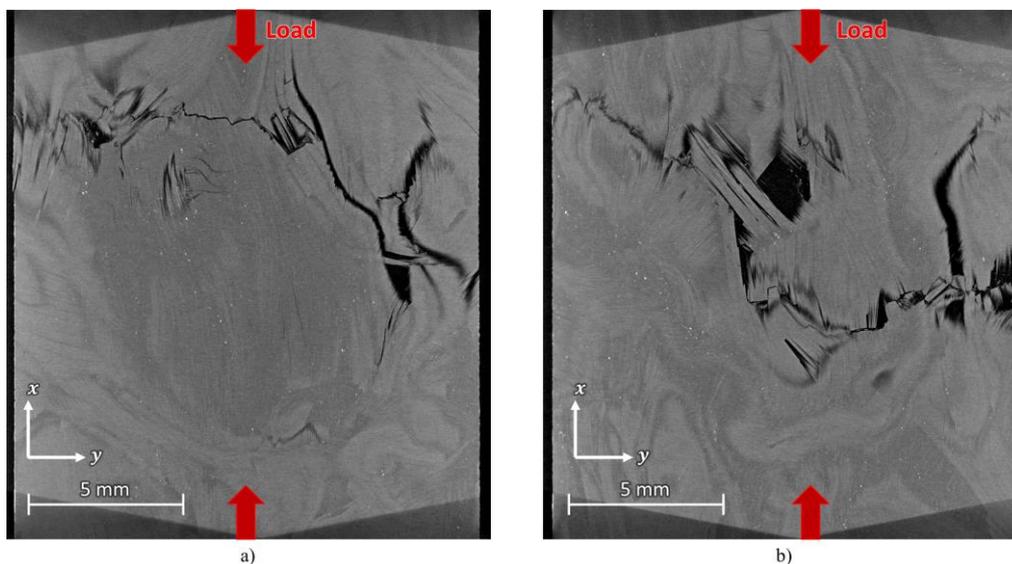
Fig. 15. Examples of in-plane slices of a compression failed 0° sample. Red arrows indicate load direction.

Straight sharp edges, like those reported in Fig. 15, were commonly observed in the 0° group. These are intra-tow features, often perpendicular to the tow axis itself. This

suggests tow failure is caused by local tow buckling along the longitudinal direction of the tow. A higher frequency of these straight sharp edges in the 0° tows is another confirmation of this hypothesis.

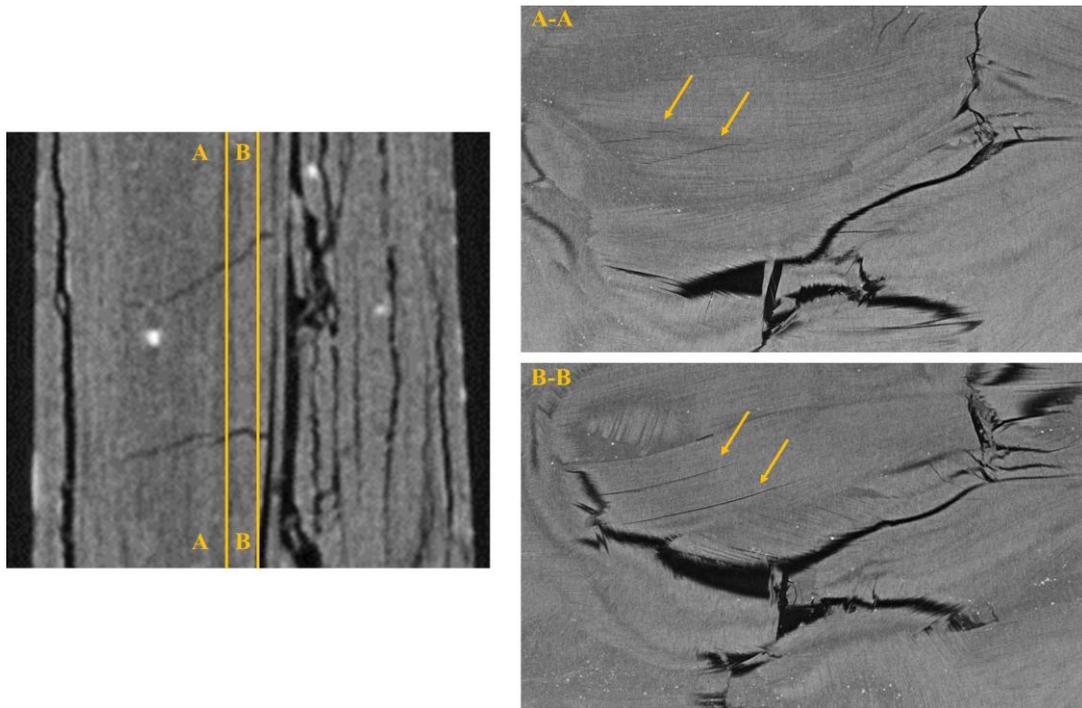
Fig. 16. Split tows in compressive failed samples. The slice on the left is perpendicular to load direction; for the details slices on the right, load direction is horizontal.

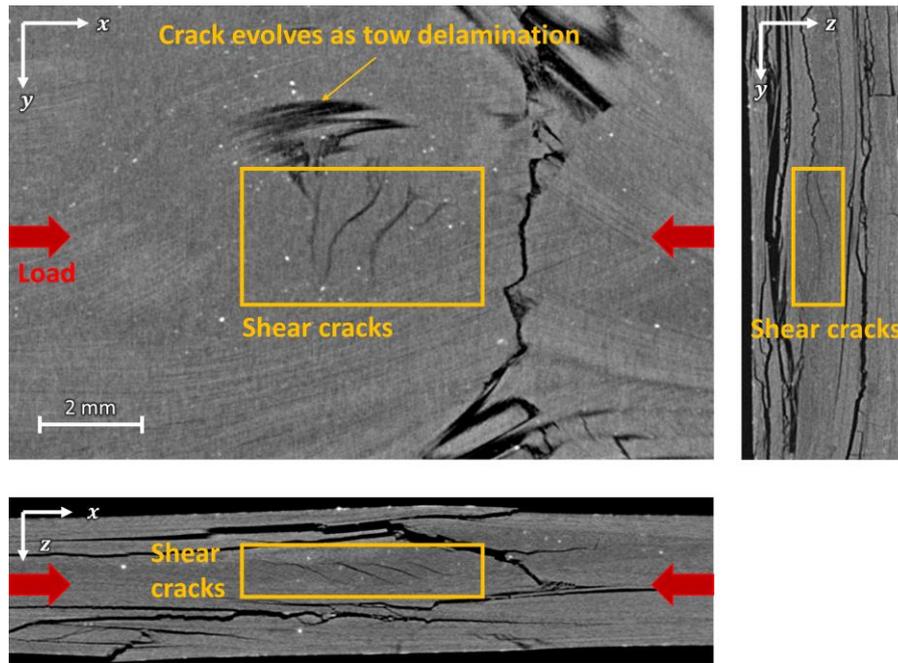
Shear cracks were observed in matrix rich areas. Fig. 17 shows an example of such a crack, with the S-shaped profile. Following the indications of Purslow [40], this suggests that the complex microstructure surrounding a resin pocket induces locally shear stress with significant components in all three directions. Note that these shear cracks usually propagate as delamination along the tow interface.

Fig. 17. 3D observation of a shear crack in a 0° specimen. The crack propagates along the tow boundary as delamination. Red arrows indicate load direction.

Regarding compressive failure mechanisms, Fig. 17 has shown the presence of matrix shear cracks and tow debonding. It is reasonable to assume that the failure starts in the matrix undergoing shear, and then propagates through the tow-matrix interface. The cracks keeps propagating until the material is no longer able to sustain the applied load. In addition, in the 0° case, tows buckling was also commonly observed. Shifting from matrix to fibre dominated failure highlights the major load carried by the reinforcement and explains the higher strength values for the 0° specimens.

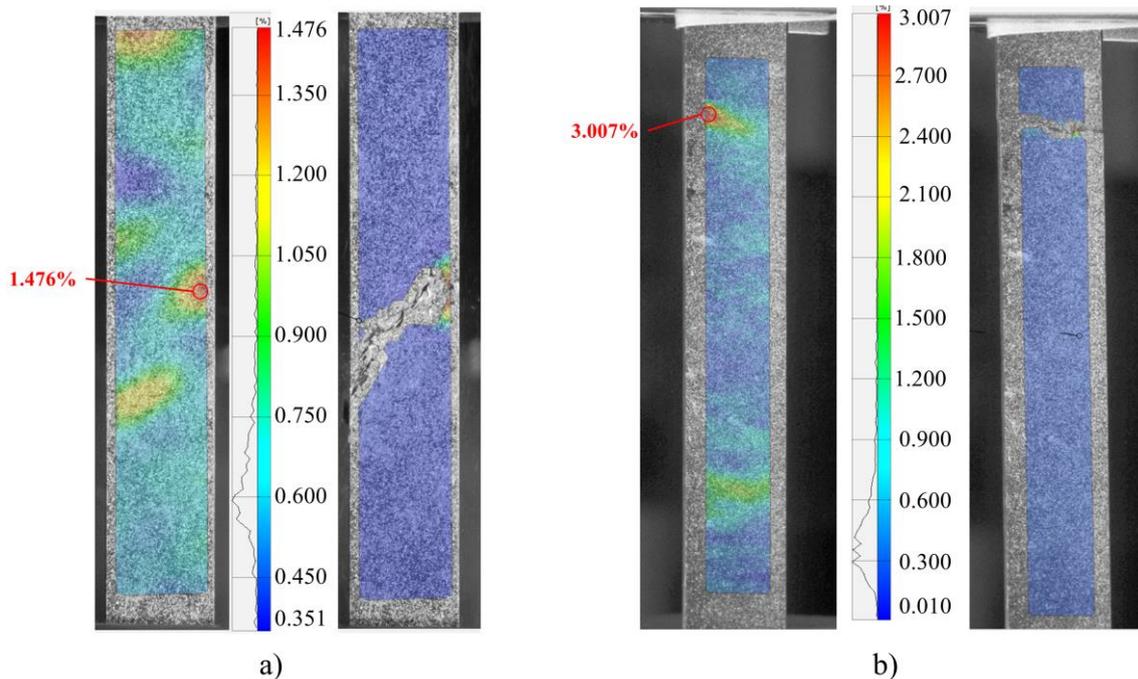
It is arguable that Table 3 and Table 4 report lower values of failure strain than those generally observed for fibre and matrix dominated failure. However, this is mainly due to the variability of local structure and properties of the SMC material. In fact, the failure strain that lead to failure was locally much higher. Fig. 18 shows DIC results for two specimens (one 0° and one 90°) immediately before and after failure. For the 0° specimen, failure occurred at an average strain of 0.683%, but at a local strain of 1.5%, much closer to the 2% failure strain of the fibres. The 90° specimen average failure strain was 0.537%, while local maximum value was 3%, high enough to justify a matrix-dominated failure. The strain variability can also be appreciated by looking at the histograms reported next to the scale bars. The proximity of the high-strain region to the specimen's edge is attributed to the material variability and not to the cutting operation. This was confirmed by other specimens that featured more central high-strain regions.

Fig. 18. Maps of the longitudinal strain during the tension tests, immediately before and after failure, for a) a 0° and b) a 90° specimen.

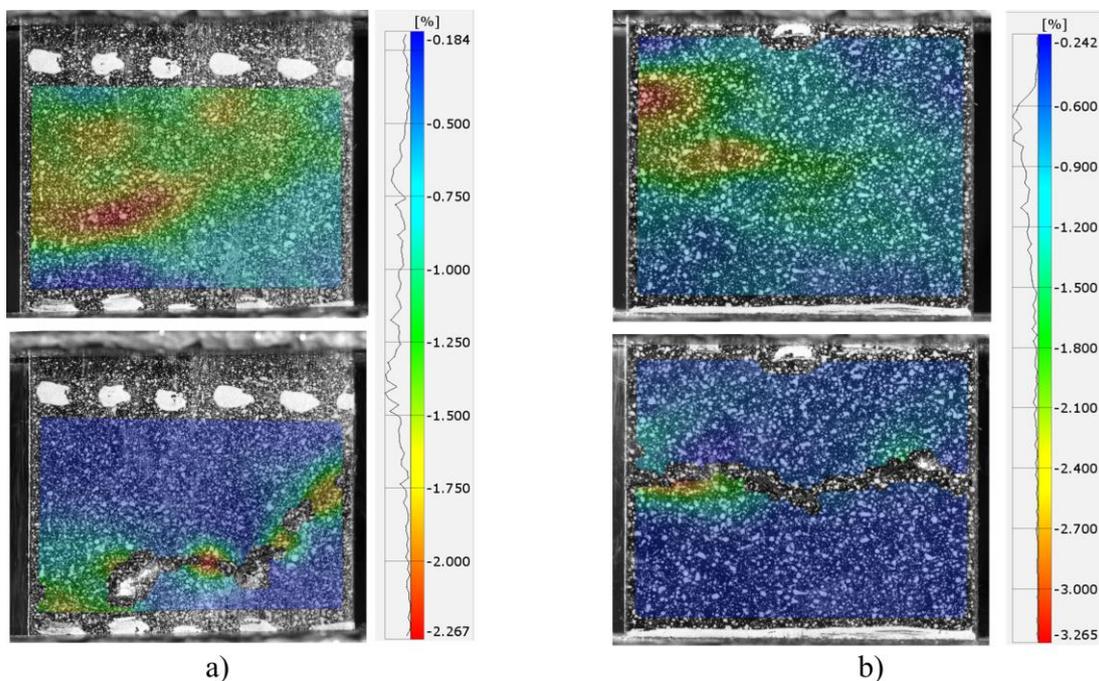
Fig. 19: Maps of the longitudinal strain during the compression tests: images on top show map right before failure; images on the bottom show failure location for the a) 0° and b) 90° specimen.

Another possible explanation for the higher compressive strength can be found in the material variability. Strain variations are much lower in the compression specimens, since their gauge length is 20 mm, smaller than the length of the tows, which is 25 mm. Therefore, the compressive failure is less likely to be triggered by local strain concentration areas than for the tensile failure. This can be observed in Fig. 19, where DIC results are shown for both 0° and 90° case. Interestingly, compressive failure often occurred in the location of the highest strain gradient, instead of the highest strain.

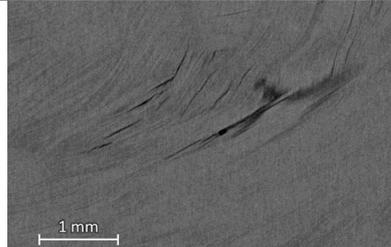
Small cracks running inside the tow, along fibre direction. Probably fibre matrix debonding.
Intratow cracks (failure)

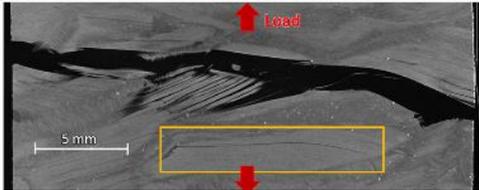
Cracks running inside transverse tows, created during loading. Observed mainly for 45° and 90°, both in tension and compression.

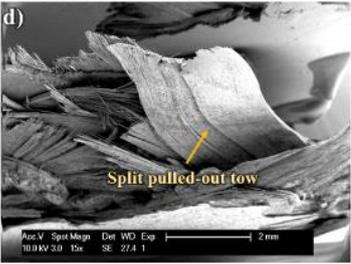
<p>Pulled out and broken tows in fracture surface of tensile specimens. Mainly observed in 0° specimens, more rarely in 45° and 90°. Pulled-out tows were frequently also split.</p>
<p>Tow buckling</p>

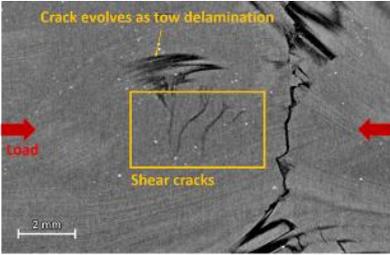
<p>Shear cracks observed in resin pockets of tested specimens (not manufacturing feature). The cracks would then evolve upon further loading along the tow interface as debonding. Observed after both tensile and compression load. Observed in all orientations.</p>
